SERVICE BULLETIN

P25 MODULE PROGRAMMER INTERMITTENT ELECTRICAL PROBLEMS

BULLETIN NUMBER: SB-0010
REVISION: A
DATE: APR 2004

PRODUCT DESCRIPTION: P25 MODULE PROGRAMMER

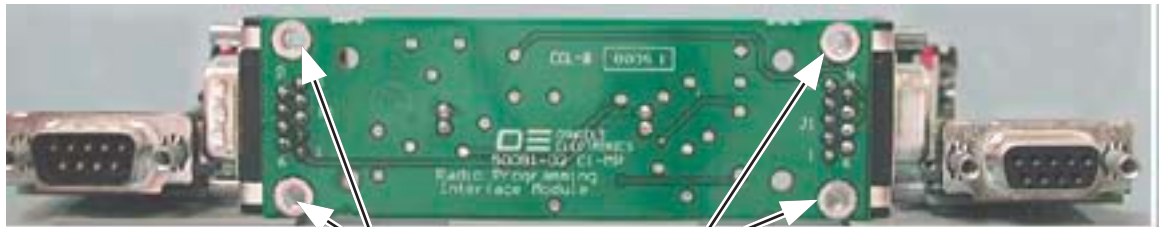
CAUSE: Internal connection is losing connection to ground plane when moved during operation.

Screw Heads on This Side

SOLUTION: Adding screws, lock washers, and nuts to hold connectors to the printed circuit board to eliminate electrical interruptions by insuring proper contact to ground.

- 1) Remove plastic housing from circuit board.
- 2) Insert screws in locations shown below with screw heads as indicated.
- 3) Secure Lock Washes and Nuts.
- 4) Replace plastic housing.
